## Leaking Shower Diverters

### Summary

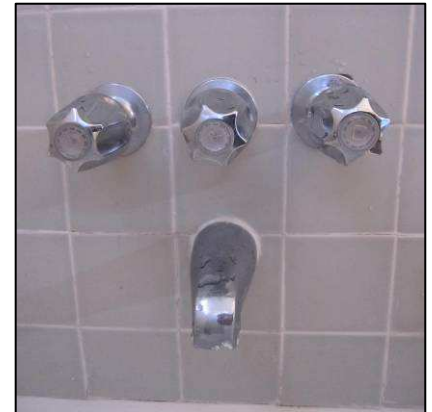
**Figure 1: A diverter valve as part of a three-handle shower valve**

Diverter valves like the one shown in Figure 1 use a valve to direct the flow to the showerhead or the tub spout. These diverters can either be part of a three-handle shower valve assembly, or they can be a separate valve installed above the valves that control the water.

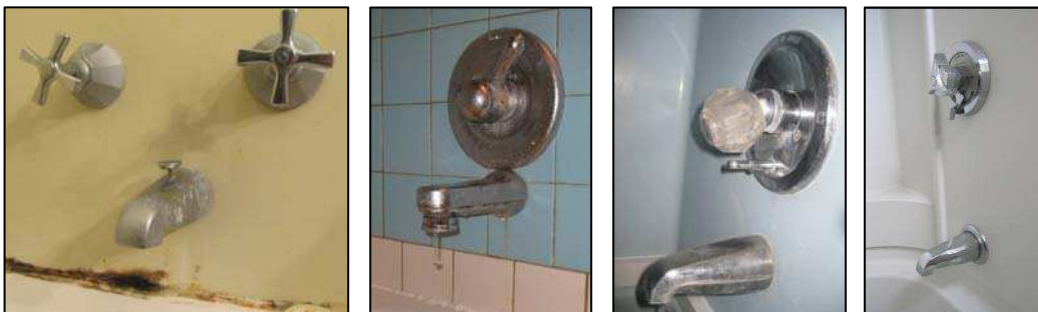
**Figure 2: Examples of plate diverters. From left to right: a lift on the tub spout diverter with a two-handle valve; a pull-down ring on the tub spout diverter with a single-handle valve; a button on the valve plate with a single-handle valve; and a sliding lever on the valve plate with a single-handle valve.**

Plate diverters like those shown in Figure 2 use a plastic or metal plate to stop the water from flowing out of the tub spout. The water gets diverted to the showerhead instead. Plate diverters can be used with single-handle valves or two-handle valves, and the diverter can be located on the tub spout or on the valve body. Also, some plate diverters are held in place by water pressure alone, while others have an integral spring. If the diverter is located on the tub spout, it is called a tub spout diverter.

Finally, we originally hypothesized that tub spout diverters with a pull-down ring (see an example in Figure 2) would leak less than lift-type tub spout diverters. This type of diverter has a spring that holds the diverter open; perhaps the spring would help the diverters leak less. We tested two of this style diverter (TS-13 and TS-14). When we ranked the tub spouts in order of smallest leak to largest leak, we saw that

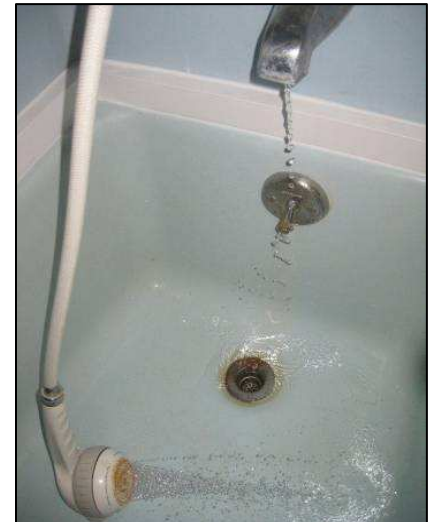
**Figure 3: A leaking diverter allows water to flow out both the showerhead and the tub spout simultaneously.**

When a diverter valve is working properly, water only flows out of either the tub spout *or* the showerhead. However, diverters very often leak significantly, allowing water to flow out of the tub spout even when in shower mode, as shown in Figure 3. This leakage goes directly down the drain without being available to the person taking a shower. Both the water and the energy used to heat the water are wasted.

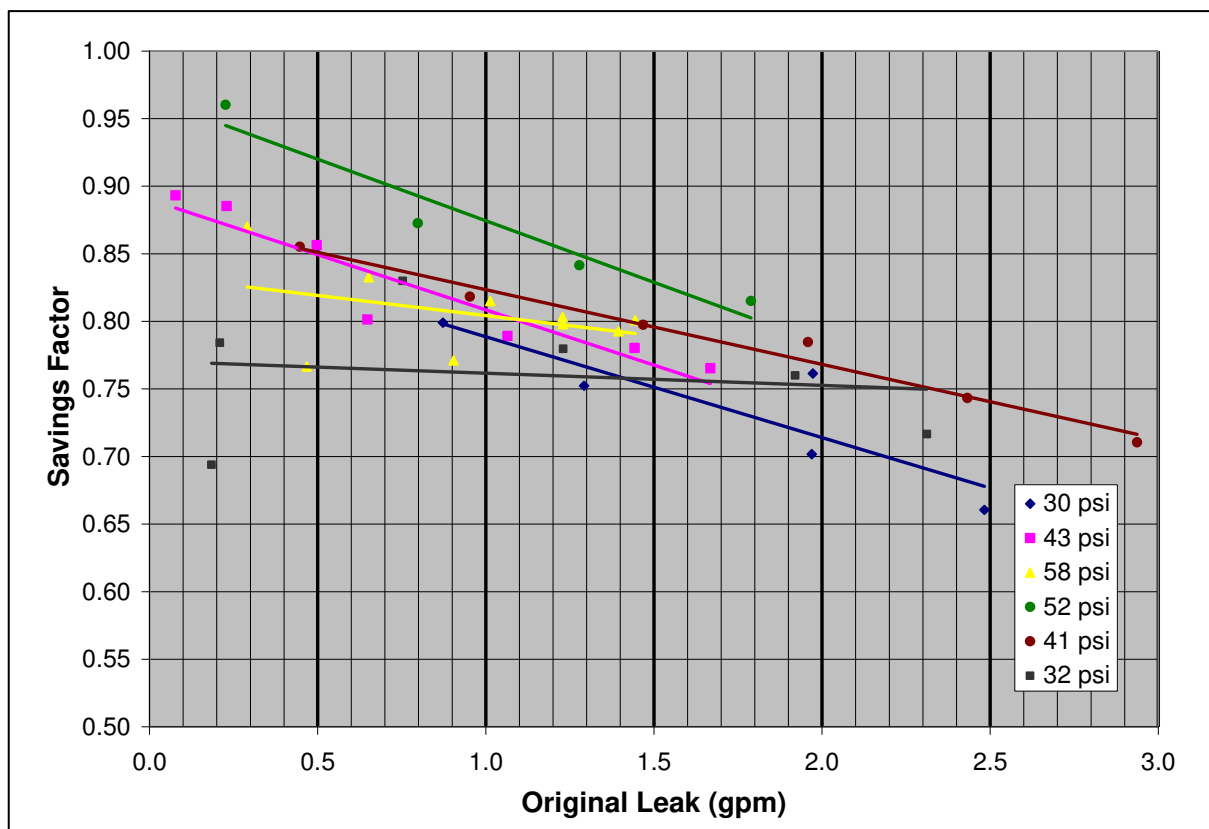
Figure 5: Calculated savings factor for SH-1 at various leaks and system static pressures

Our primary goal for this project was to determine a savings factor for energy auditors to use in order to calculate achievable savings from replacing a leaking diverter. Test 1 focused on determining the savings factor through tests. We found that in general, at a given system pressure, the savings factor decreased as the size of the original leak got larger. (See Figure 5.) We also found that the savings factor was almost always greater than 0.7, regardless of the showerhead, system pressure, or leak flow.
